# Manhole Inspection Summary

Manhole # S21GG\_033MH

Insp Date: **6/15/07 9:18 AM**

**Location** Address: **1560 FULTON-MCKEAN**

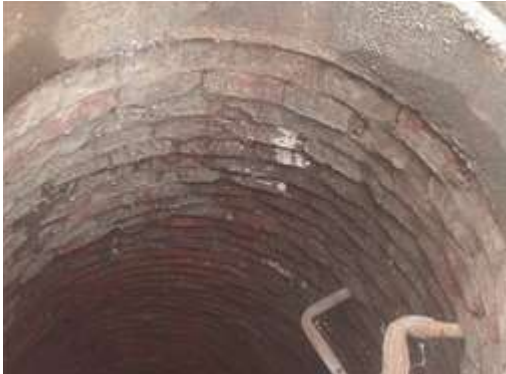
Defect 2

Infiltration: ☐ None ☐ Joint ☐ Cracks ☐ Mortar ☐ Roots ☒ **Wall**

INFILTRATION OF CHIMNEY

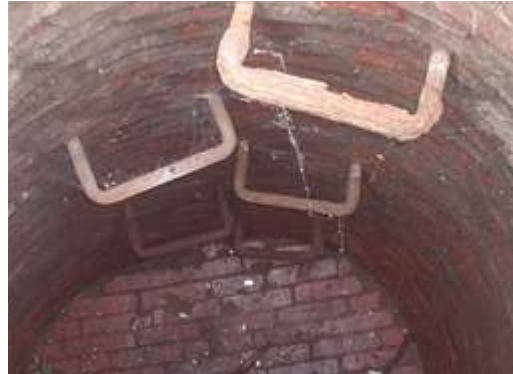
Defect 1

**Steps** Count: **5** Missing: **0** ☒ **Corroded**

CORRODEDE STEPS

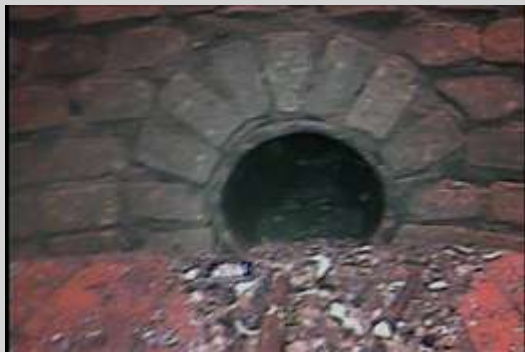
12 O'Clock Outflow

DEBRIS IN CHANNEL

Deposits: ☐ None ☐ Mud ☐ Sludge ☒ **Debris** ☐ Grease

Silt Depth: **2** (in.) Deposits Extent: **Light**
